December 1960

AUTO-VAP MOPED - LIGHTING

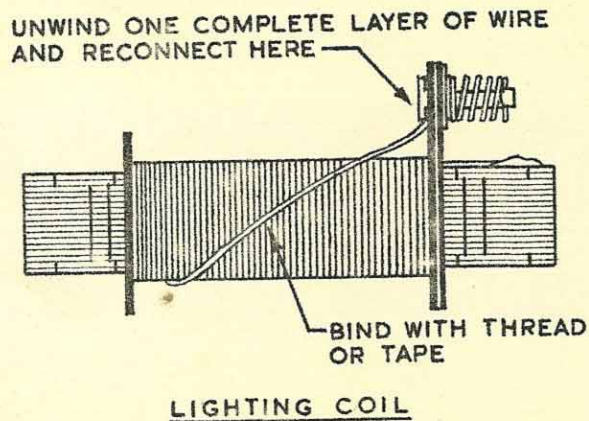
If persistent bulb blowing is experienced with either the head or tail lamp bulbs and assuming that the trouble is not being caused by loose bulbs or fittings, we suggest that the following modification be made to the lighting coil:

- (1) Remove the main feed wire from the terminal post. Remove the lighting coil from the Magneclair assembly, this is held in position by two spring clips which can easily be prised away from the coil with a screwdriver.
- (2) Cut the wire at the spring terminal post connection and unwind one complete layer of wire. Cut the wire that has been unwound from the coil leaving sufficient length to connect up to the spring terminal post.
- (3) Scrape the shellac covering from the end of the wire and pass the wire through the terminal post.
- (4) Bind the winding with a few turns of thread or insulated tape to prevent slackening of the winding.
- (5) Replace the coil and reconnect the main feed wire to the terminal post.
